Project No. 11097  
November 28, 2012

**Subject: Site Visit to Review Implementation of Revised Major Subdivision Plans  
Hunt, LLC – 2-Family Residential Subdivision aka Ruby Way  
Carroll Tax Map 207, Lot 36, off Paquette Drive**

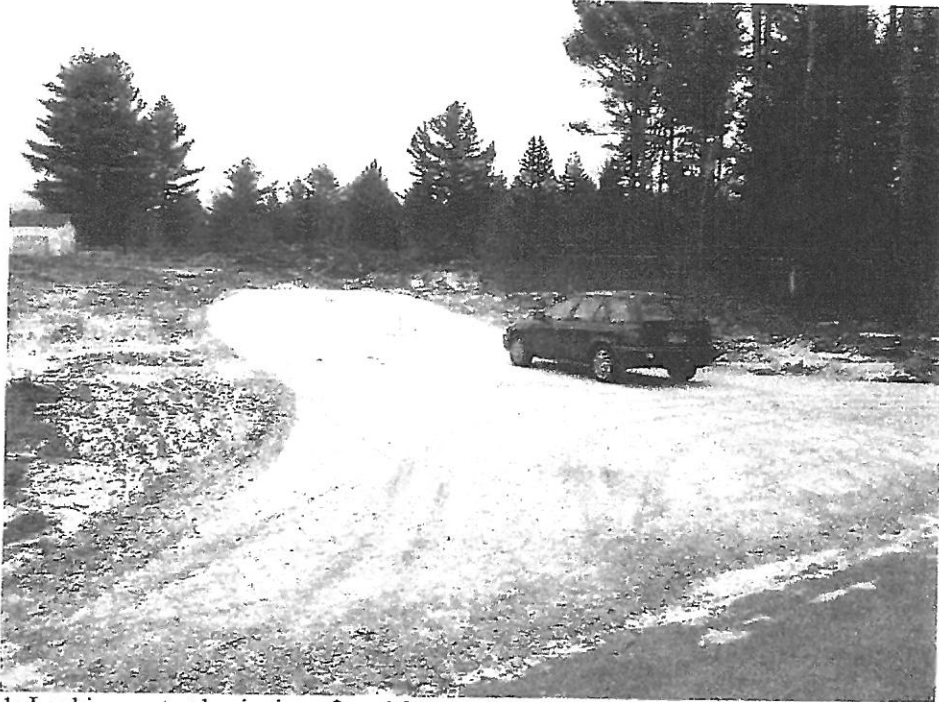
- The road base consisting of bank run gravel and crushed gravel has been placed approximately 28 feet wide from Paquette Drive approximately 150 feet to station 1+50. This appears to be in conformance to the plans.

Photo 1: Looking east at beginning of road from Paquette Drive. Crushed gravel has been placed to approximately station 1+45 (145' from the edge of Paquette Drive).

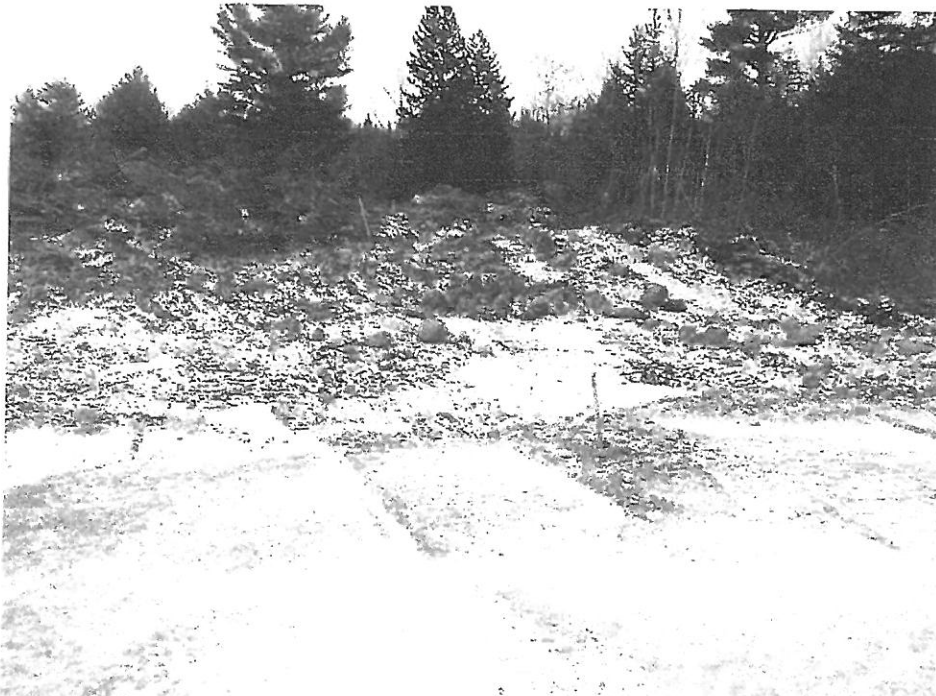
Photo 2: Looking along roadway at end of built roadbed. Bank run gravel has been placed slightly beyond station 1+50 (grade stake in foreground is 1+50).

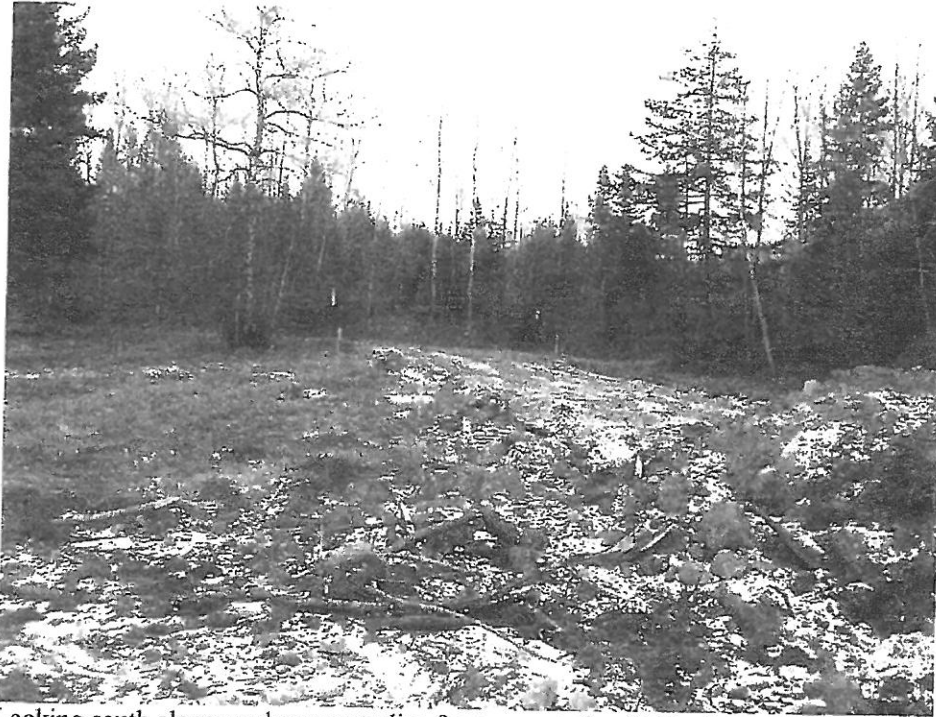
- Some grubbed materials are piled at station 2+50, and several small piles of concrete demolition debris are present including at station 2+75.
- Some topsoil has been stripped in the location of the vegetated swale station ~3+50.

Photo 3: Looking south along roadway centerline from near station 3+00. Some topsoil has been stripped. No work is apparent beyond station 4+50 (at treeline in this photo).

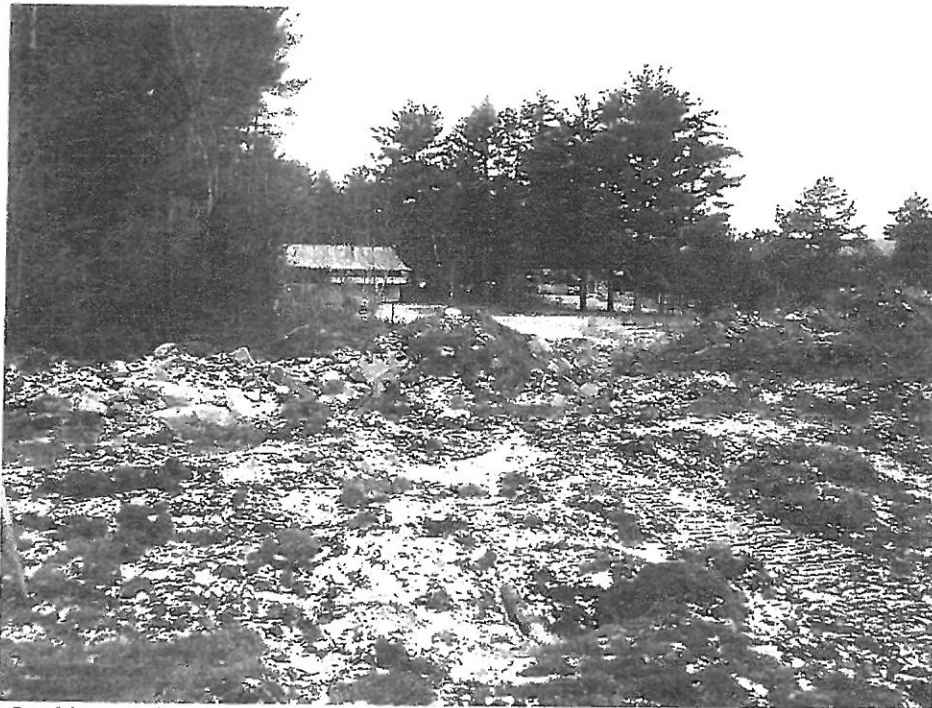
Photo 4: Looking northwest (toward Paquette Drive) from near station 3+00. Concrete debris piled on left and grubbed materials piled on right.
